Mattley Meadow Aquatic Resource Delineation

Prepared By:
Plumas Corporation
PO Box 3880
Quincy, CA 95971
530-283-3739

Prepared For:
Stanislaus National Forest, Calaveras Ranger District
5519 Highway 4
PO Box 500
Hathaway Pines, CA 95233
(209) 795-1381

February 24, 2020

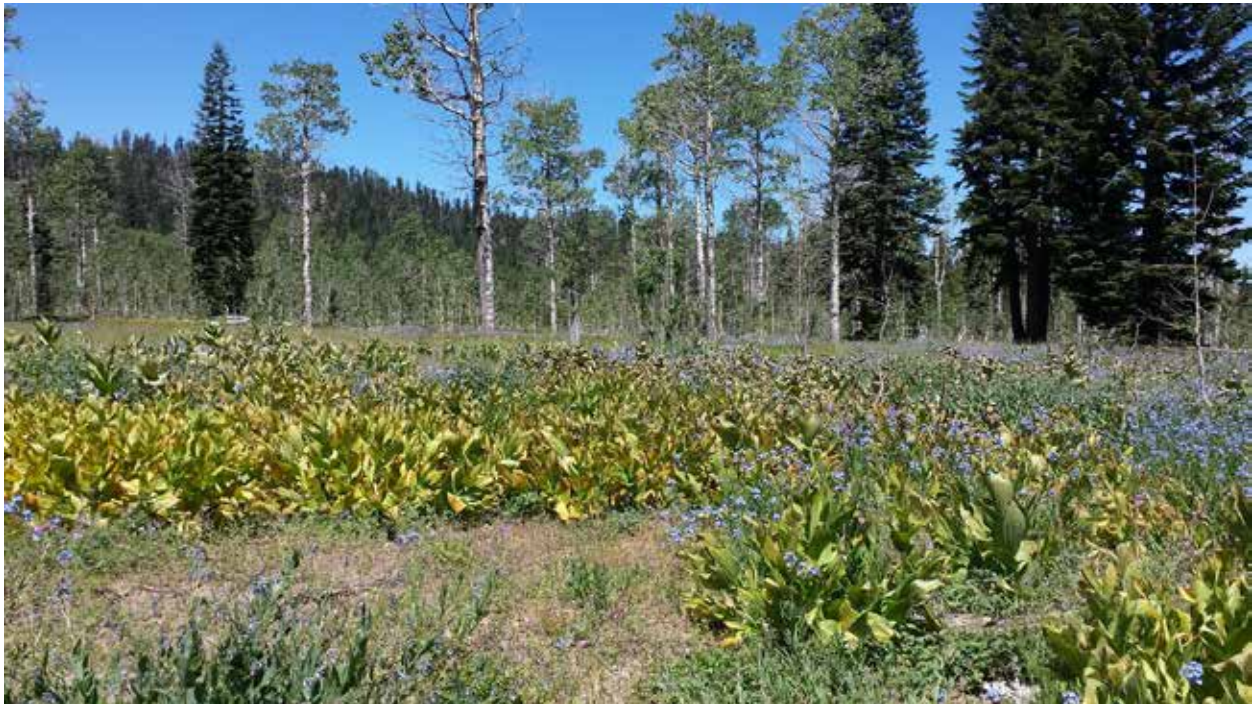
Mattley Meadow near the east gully, July 7, 2016.
